Inspection Report
Minerals Regulatory Program
June 4, 2009

Mine Name: Yerian
Operator Name: Neffco Mining and Manufacturing

Permit number: S/047/0087
Inspection Date: May 5, 2009
Time: 4:15-4:45 PM

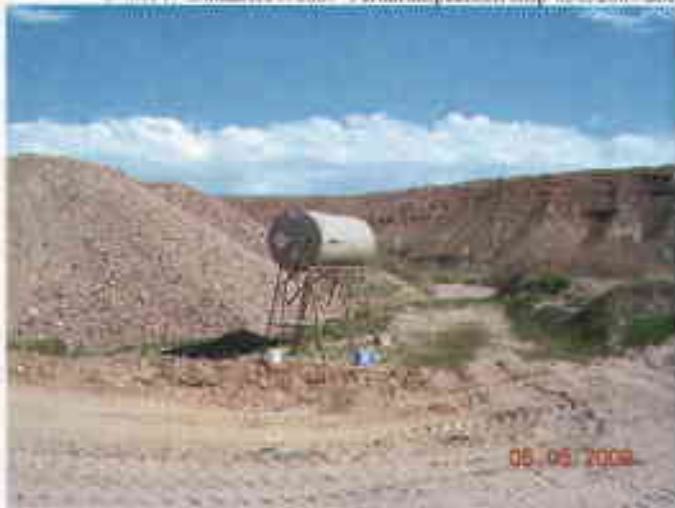
4. Deleterious Materials
There is a fuel tank with no containment (Photo 1)

Photo 1. The fuel tank needs to be in a lined containment structure.

The fuel tank needs to be in a lined containment area.

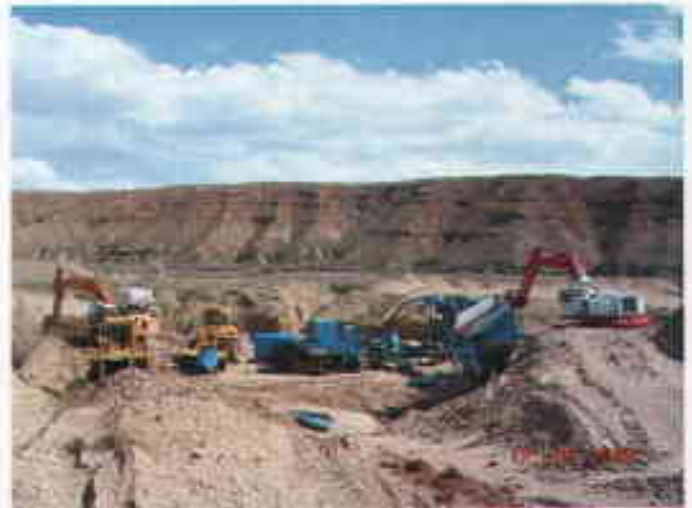
Equipment on site includes two trackhoes, two loaders, two pumps, a semitrailer, and a camper trailer (Photo 2). There is also a boneyard (Photo 5).

Photo 2. This shows most of the equipment.

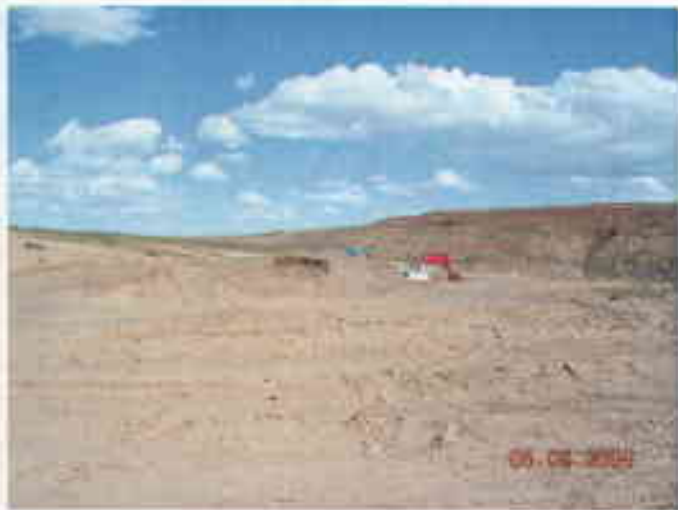
Photo 3. This is part of the disturbed area looking back toward the equipment in Photo 2.

The operator should start to do some concurrent reclamation so the disturbed area does not exceed five acres.

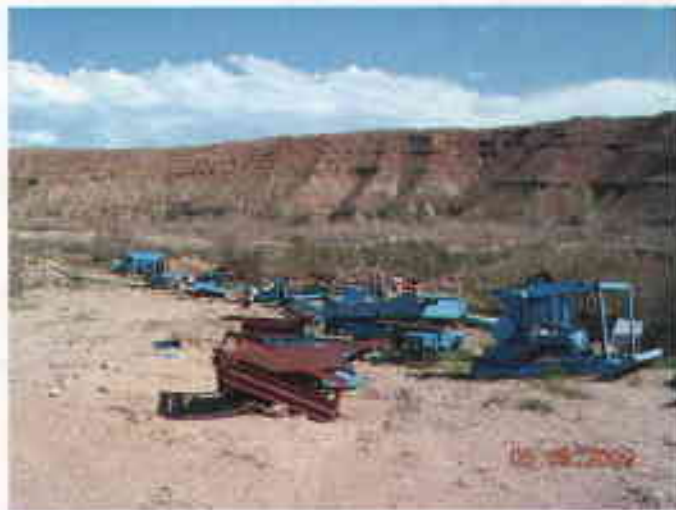
Photo 5. Boneyard.

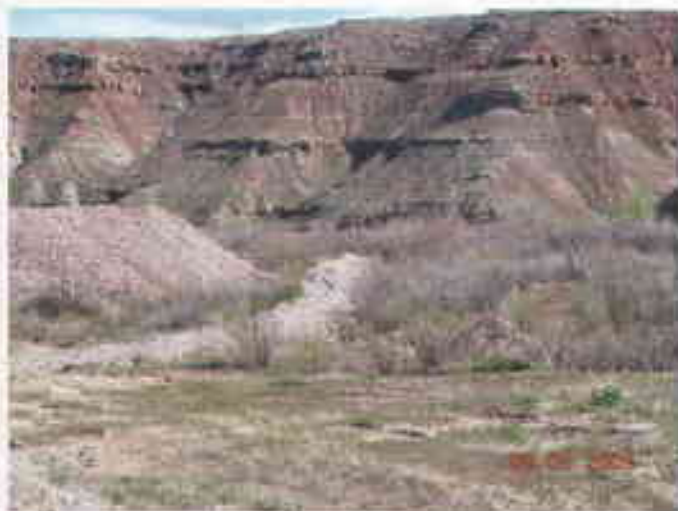
6. Concurrent Reclamation
The last time I inspected this site, it was just over four acres, and I did not include any disturbance from the water line (Photo 4). During the current inspection, I was not able to map the area because my GPS unit was not charged, but my general impression was that the disturbed area has expanded. The disturbance from the water line is about one-half acre, so the operator is very close to the acreage limit.

Photo 4. The water line that leads to the river. It is just over 1000 feet long.
